Manhole Inspection Summary

Manhole # S31GG2012MH

Location Address: **46 LAKE AVE**

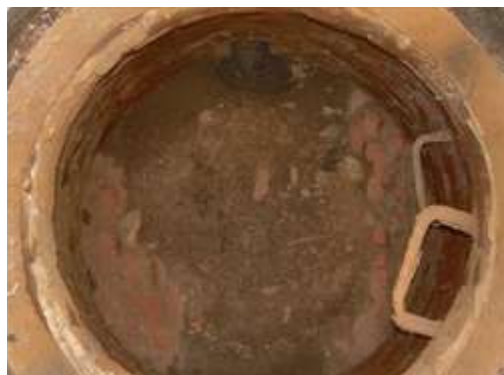
Top View

Corroded steps. Channel debris.

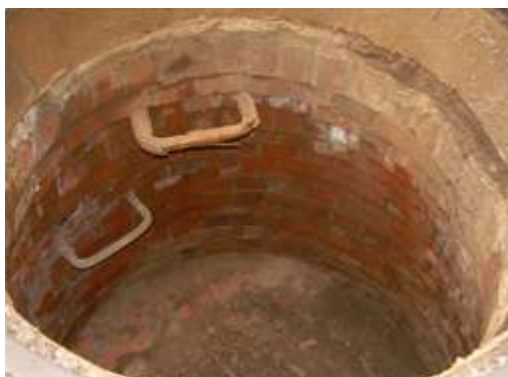
Defect

Frame leaks. Adjustment deterioration and infiltration. Corbel and Barrel infiltration - other side.

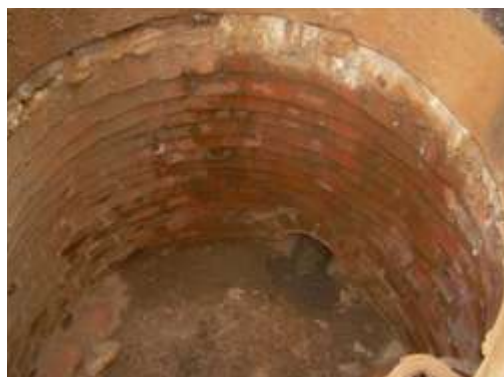
Defect

Frame leaks. Adjustment deterioration and infiltration. Corbel and Barrel infiltration.

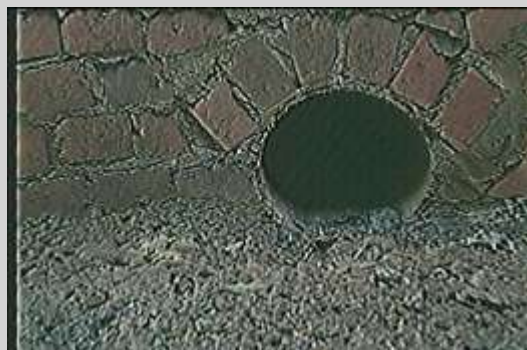
Pipe Out @ 12 O'Clock

Deposits: ☐ None ☒ **Mud** ☐ Sludge ☒ **Debris** ☐ Grease

Pipe Seal Cond: **Cracked**
